Electrostatic Purification Helps Pulp Mill Control Sludge and Varnish

A Reprint from *Practicing Oil Analysis* magazine

By DAVID M. BICKFORD, ASL TECHNOLOGIES LLC

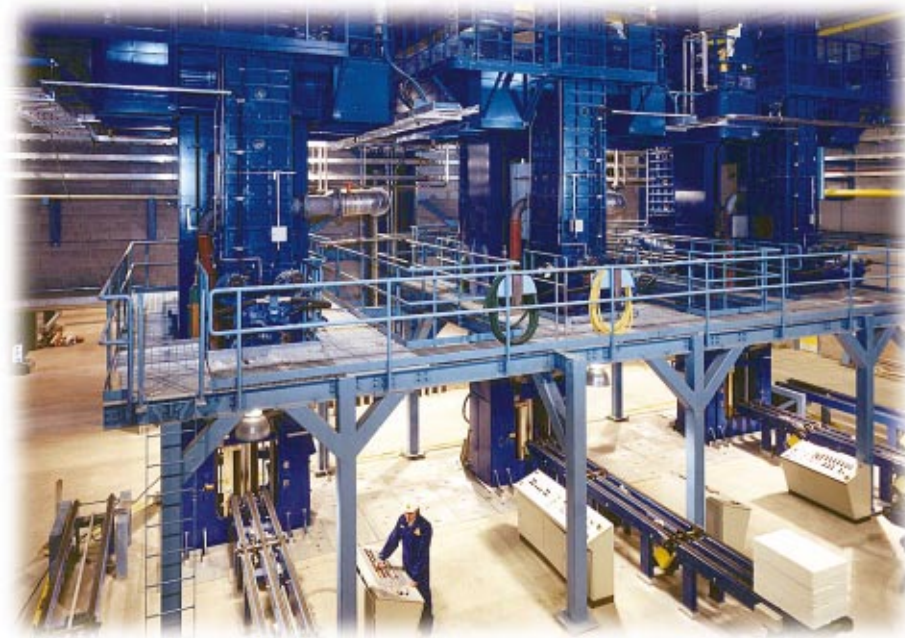
Millar Western's slab presses are high-production machines that apply 400 metric tons of force with a large vertical stamp, three or four times through each cycle.

Millar Western has three identical slab presses in its Whitecourt CTMP facility, one of which was initially targeted for the trial. The slab presses compress pulp into large, rectangular bales that are ultimately shipped out to the company's customers - paper manufacturers. Once the pulp is refined, washed and bleached, it is put through a drying process that results in a fluffy, 93 percent bone dry pulp. This dry pulp gets distributed to two storage chutes within each slab press. Each slab press is a high-production machine that applies 400 metric tons of force with a large vertical stamp, three or four times through each cycle, to compress each 225-kilogram (500-pound) bale. The cycle time to produce each bale is between 35 and 60 seconds, depending on the desired production rate, with typical hydraulic system pressures of 200 to 250 bar (2,900 to 3,600 psi).

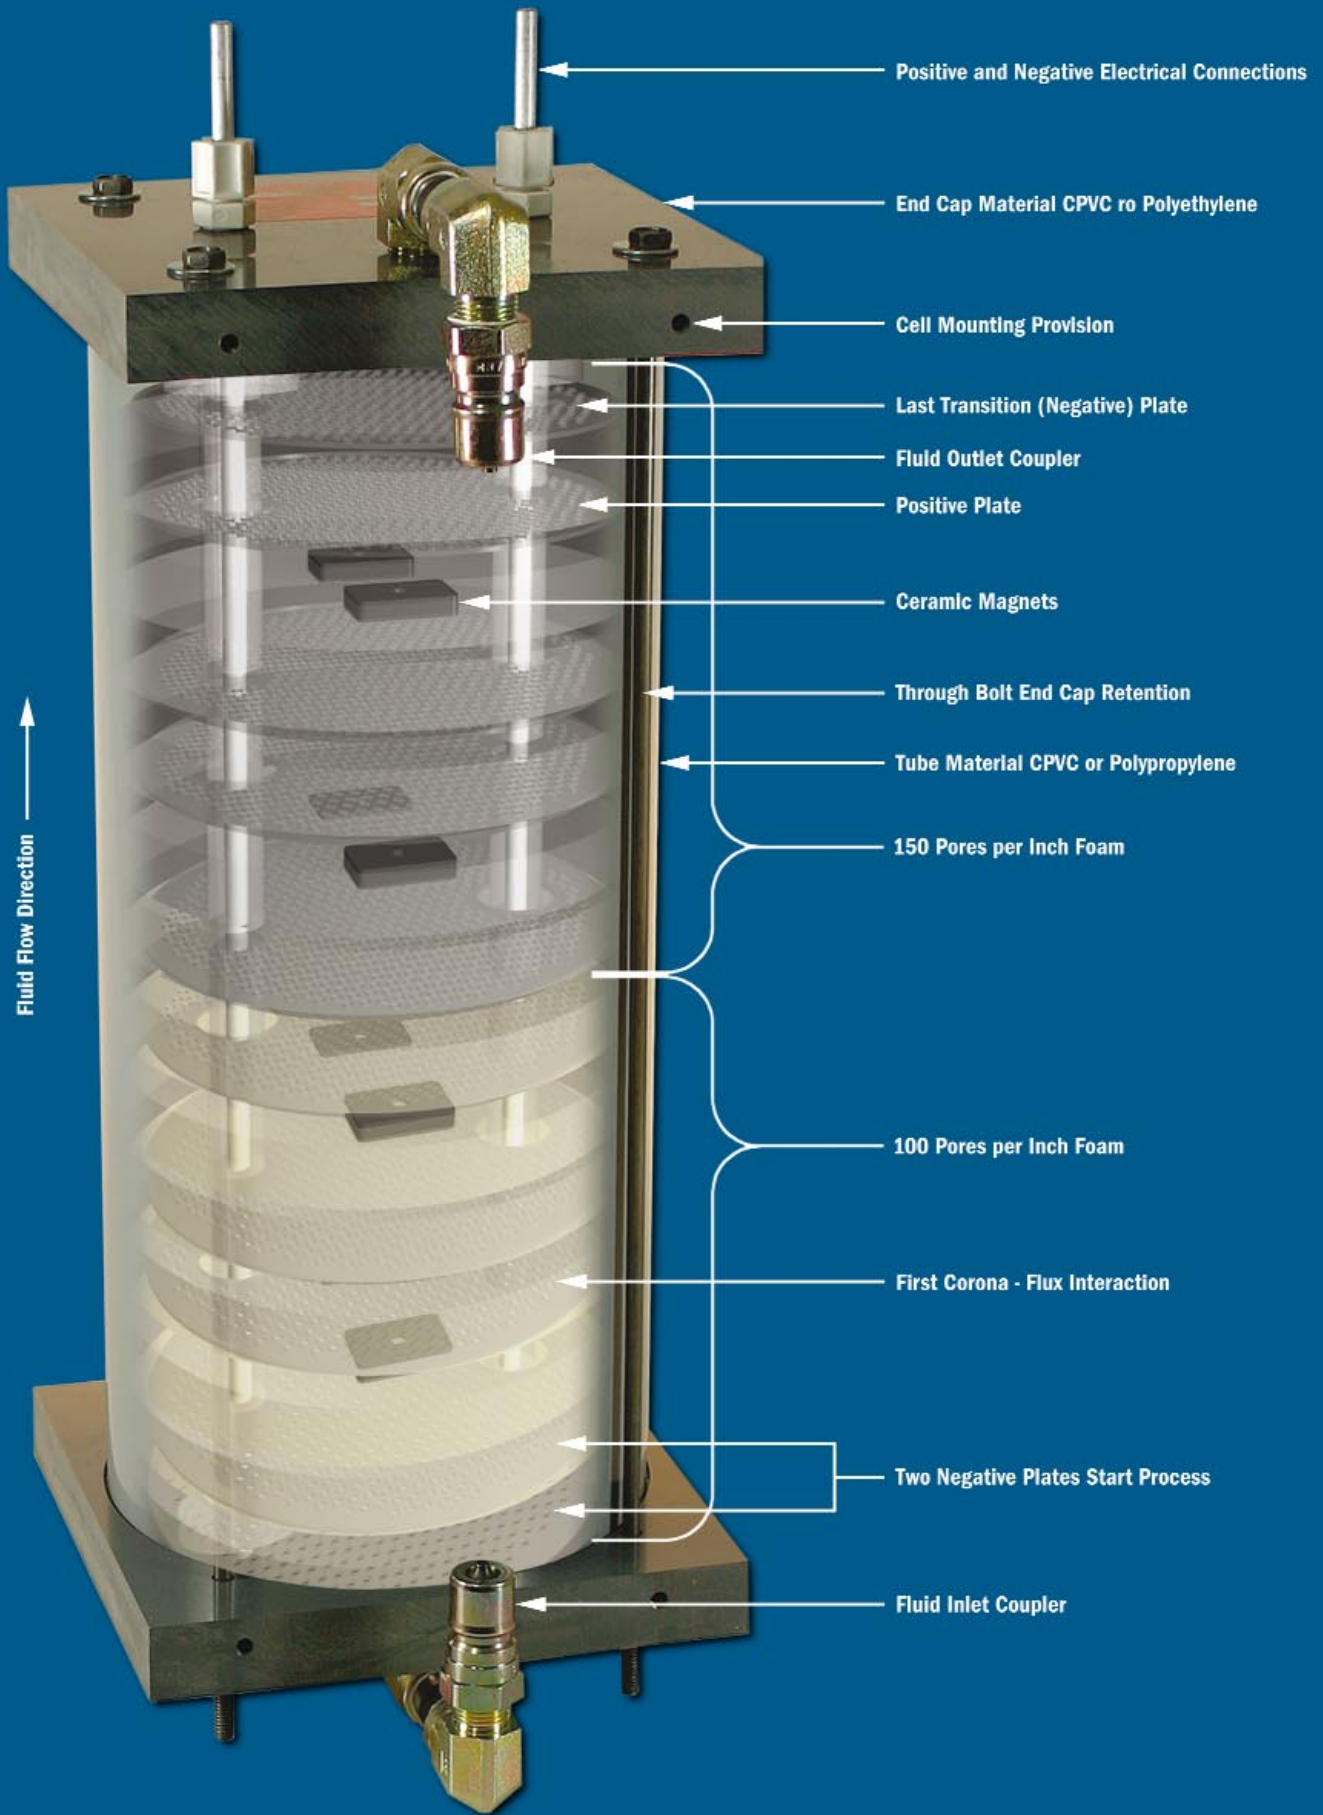
Figure 2. Electrostatic Cell Construction

The electrostatic chamber or cell is a cylindrical shell, or tube, capped with square end blocks. The necessary provisions for fluid inlet, outlet, mounting and electrical connections are located in the square end blocks.

Fluid to be cleaned first enters the cell at the bottom (Figure 2), where it collects and fills in the expansion area so that the entire cross-sectional area of the cell is exposed to the fluid. As the force of the pump moves the contaminated fluid upward, it immediately encounters the first perforated metal plate, which has a negative charge. Passing through this plate, some particles become negatively charged due to an inductive effect, and are repelled upward by coulomb forces. Many of these charged particles then remain in the pores of the filter media immediately above the plate. Likewise, any particle entering the cell that already has a negative charge is similarly repelled by the first plate, and may also become trapped.

The electrostatic chamber or cell, shown in Figure 2, is a cylindrical shell, or tube, capped with square end blocks. The necessary provisions for fluid inlet, outlet, mounting and electrical connections are located in the square end blocks.

The electrostatic cell reveals many design and manufacturing considerations. The positive and negative electrical connections, sealed by plastic compression fittings, are exposed at the top to facilitate connection to a specially designed high-voltage DC power

source via a "spark plug" terminal and rubber boot having enough length and insulating capability to shield the connections from arcing or injury.

The end caps are constructed of either chlorinated poly vinyl chloride (CPVC), for use with the more common types of hydraulic, turbine and lubricating oils, or polyethylene when filtration of phosphate ester fluids is desired. These materials are relatively inexpensive, easily machined and have little difficulty withstanding temperature ranges typically seen in most systems. To seal the end caps to the tube, O-ring grooves are machined into the caps.

Commercial quick-disconnect couplings are used to minimize external contaminant ingress and ease installation and system maintainability. Threaded holes on both sides of the end caps provide secure mounting points for the electrostatic cell. Simple threaded through bolts retain the end caps to the tube, and are affixed with positive locking nuts. Like the end cap,

the tube is made of PVC, or polypropylene when phosphate ester fluids are filtered.

The electrostatic cell depicted in Figure 2 is approximately 20 inches tall, with 7.25-inch square end caps, and weighs approximately 16 pounds dry. A single cell can operate at flow rates of approximately 40 GPH. Using the preferred formula of one reservoir cycle every 24 hours, a single cell system, with a 40 GPH pump, can support a reservoir of approximately 1,000 gallons or less. The unit is scalable such that on larger systems requiring higher flow rates, multiple cells can be connected in parallel. A reservoir of roughly 2,000 gallon capacity would require a single pump and motor of 80 GPH capacity and two of the cells pictured in Figure 1. Depending on plumbing complexity, multiple cells can effectively filter reservoirs of unlimited capacity. The largest such system built to date with this unit is a 24 cell 1,000 GPH system, supporting a 22,000 gallon turbine oil reservoir.

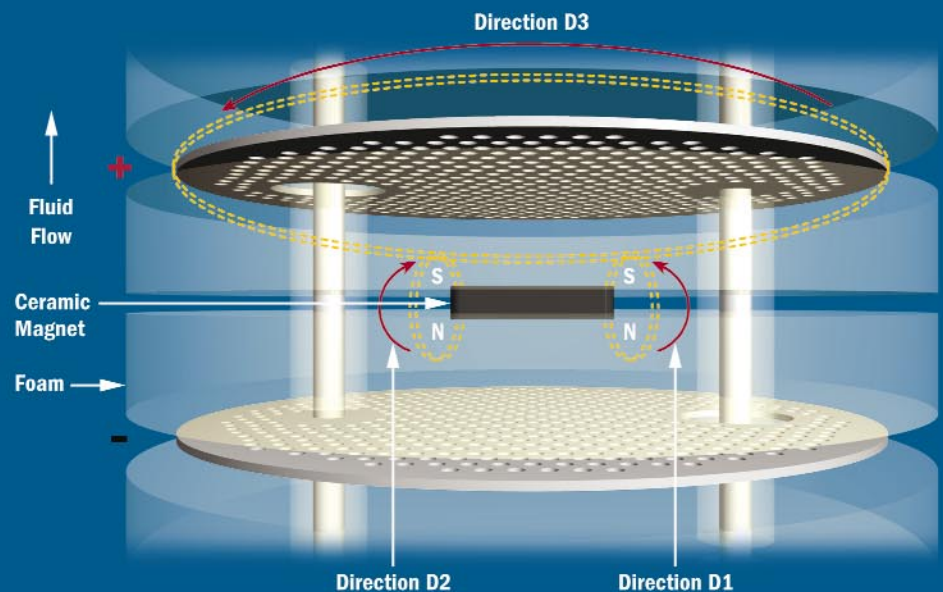
Figure 3

Permanent ceramic magnets suspended between the negative and positive plates form a toroidal flux field, acting in directions D1 and D2 (relative to fluid flow). This toroidal flux field interacts with the counterclockwise (D3) corona formed around the positive plate. As particles suspended in the fluid enter the resultant force field, the turbulence created by the interaction of these force fields causes random agitation of the particulate, causing it to become embedded within the micropores of the foam.

Different effects at different locations in the force fields tend to create greater random agitation, as the particles are accelerated at some places and resisted at others. This not only makes entrapment of submicronic sludge, varnish and oxidation by-products achievable, but also effectively doubles the holding capacity of the electrostatic cell. A microammeter connected to the cell shows the relative amount of power required to hold particulate in suspension.

Permanent ceramic magnets are suspended in the path of the oncoming particulate and the resultant magnetic flux field creates turbulence in the oil. Located just above the magnetic field, the positive plate has a clockwise revolving corona force field, which interacts with the magnetic force field, creating further turbulence, causing the particulate to become trapped, suspended in the two force fields, while the host fluid flows around it. (See Electrostatic Fluid Purification Principles Explained on page 24 for more detail.)

Already confined within the straws of the foam, particles remain in constant motion, more or less trapped in the resultant force field established by the interaction of the flux and corona. The different effects at different locations in the force fields tend to create greater random agitation. However, because the particles are already confined within the straws, this agitation causes them to become even more imbedded within the foam.

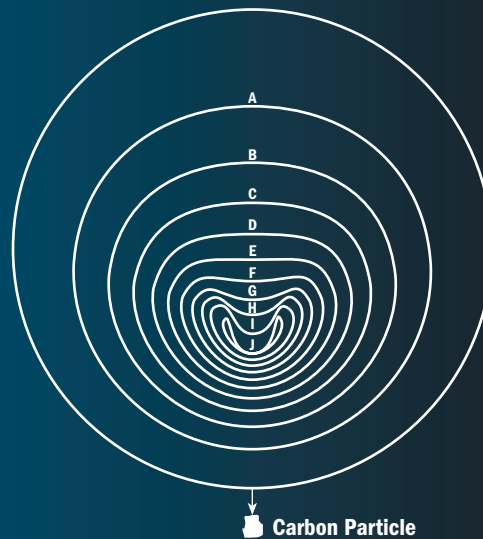
Boyle's Ideal Gas Law

Zone	Pressure	Temperature
A	Atmospheric (Pump Inlet)	100°F
F	1,000 psi	1,410°F
H	2,000 psi	1,820°F
I	3,000 psi	2,100°F

Any entrained air bubble in a system that is drawn into the suction side of the pump will be compressed. As anyone who has used a hand-operated bicycle pump will know, compressing air or any gas causes an increase in temperature: the change in temperature with pressure change is governed by Boyle's Law. According to this fundamental law of physics, compressing a gas from atmospheric pressure (the reservoir) to 2,000 psi or more (the discharge side of a high-pressure pump) will result in an increase in temperature from perhaps 100°F to more than 1,800°F, enough to turn any oil into carbon particles similar to soot - the result of burning diesel fuel at elevated temperatures. While this extreme temperature is found only in a localized area around the compressed gas bubble, over time, a significant degree of oil degradation can occur. In rolling contacts such as large rolling element bearings, where elastohydrodynamic lubrication is the norm, the situation can be even more severe with instantaneous pressures of hundreds of thousands psi.
